# Manhole Inspection Summary

Manhole # S33MM\_046MH

**Location** Address: **2013 CHARLES ST**

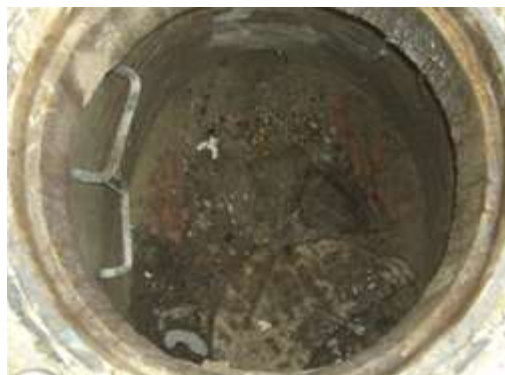
Top View

Corbel and Barrel infiltration. Channel deterioration.

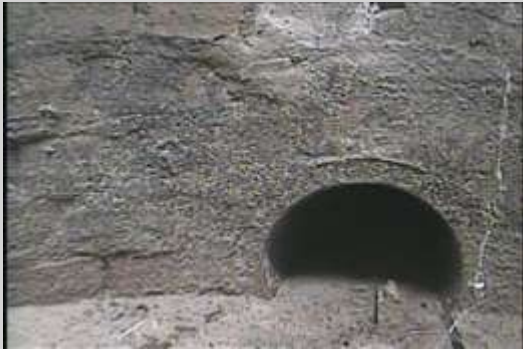
Pipe Out @ 12 O'Clock

Deposits: ☐ None ☒ **Mud** ☐ Sludge ☒ **Debris** ☐ Grease

Silt Depth: **2** (in.)

Deposits Extent: **Medium**
